**Earthquake in Myanmar**  
**Damage Map of Mandalay City and Ava Bridge**

Observed on 29/03/2025  
Charter Call 1095  
AOI No.01

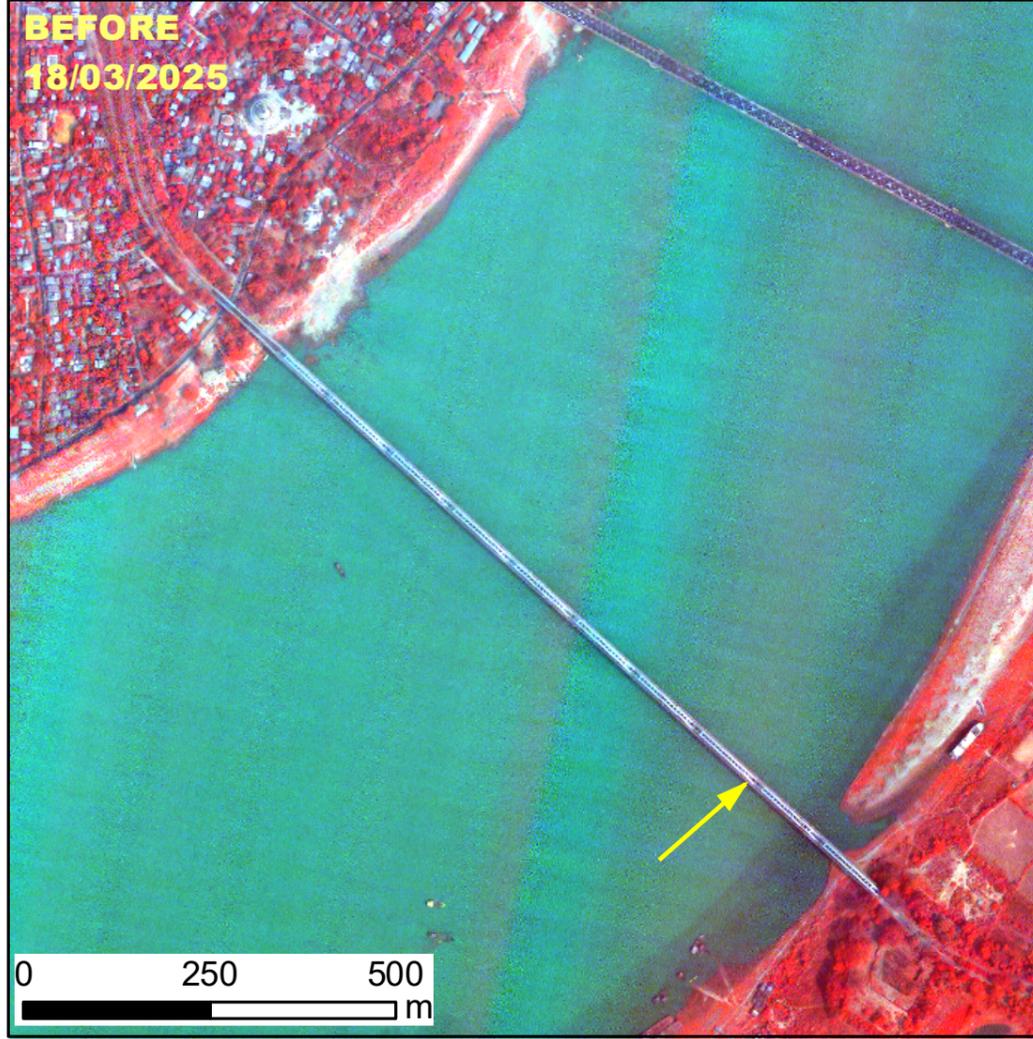
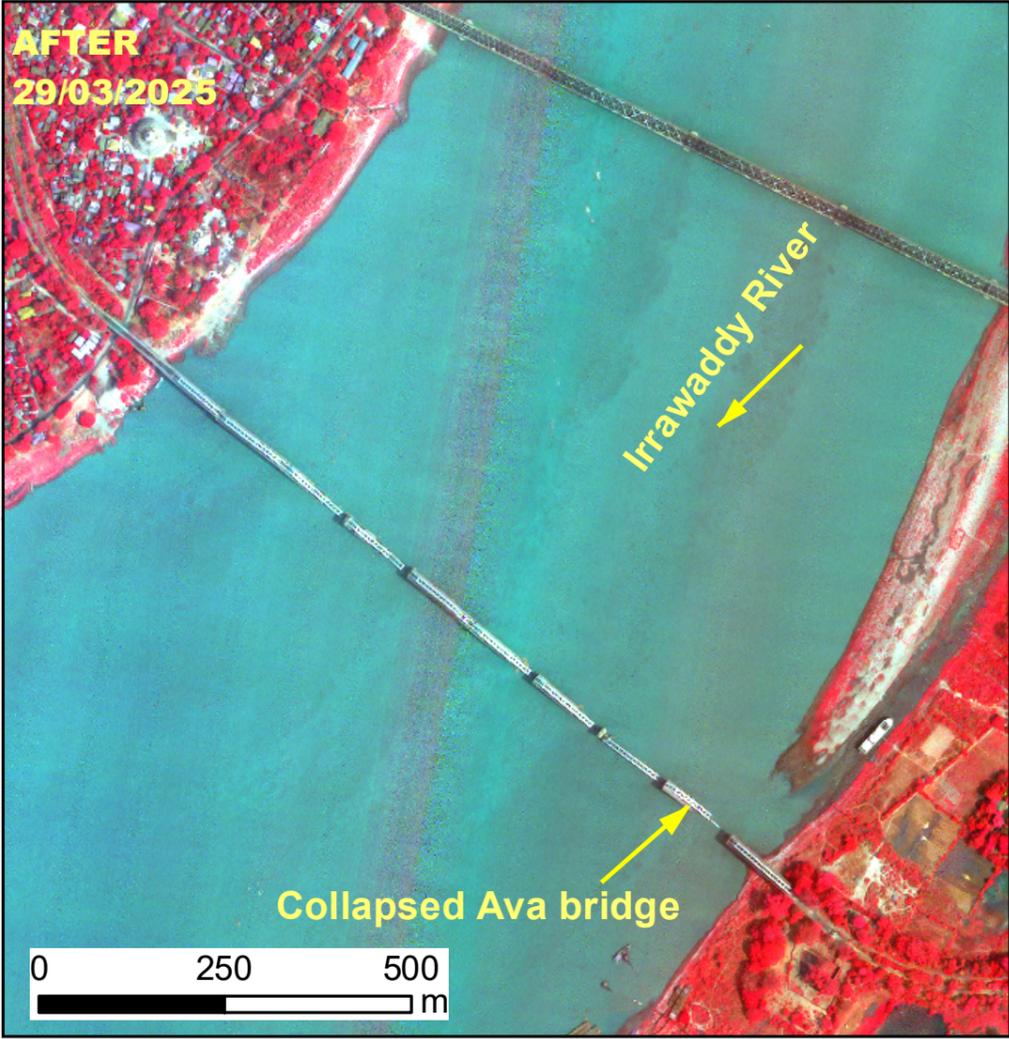
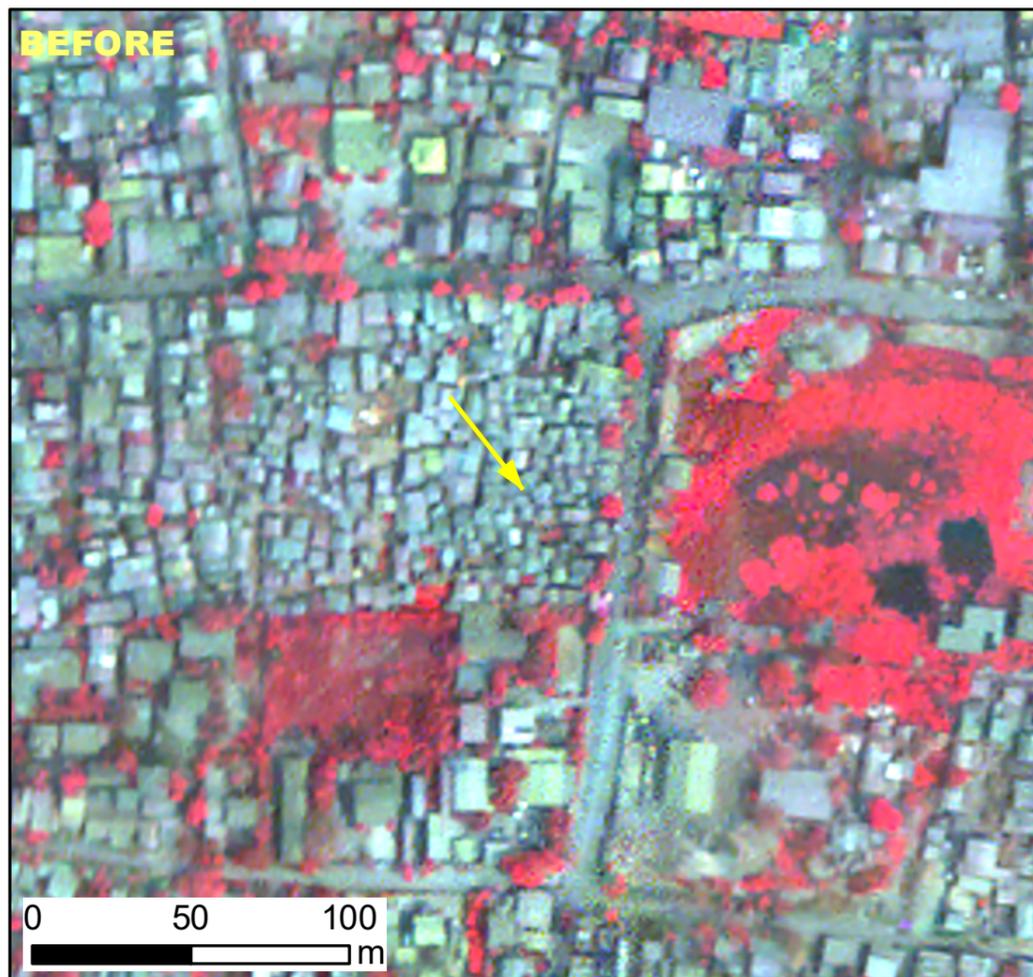
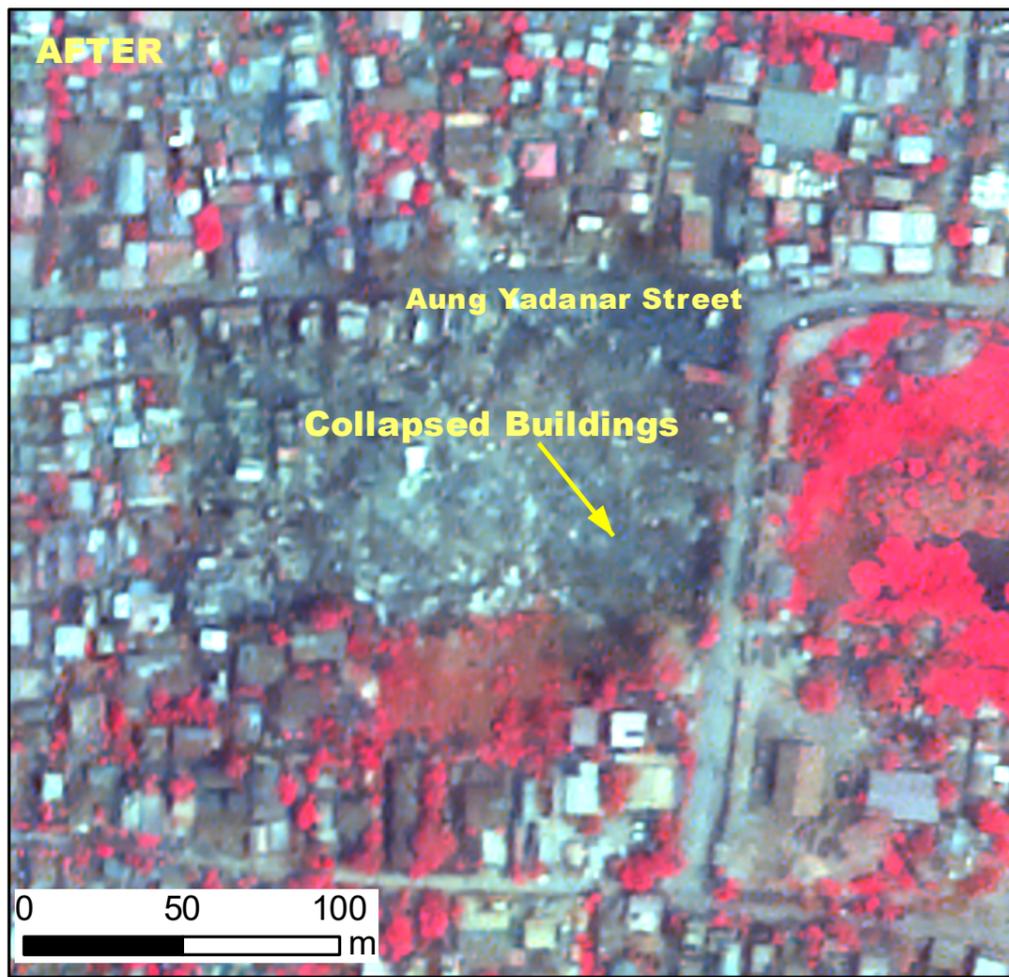
An Earthquake of magnitude 7.7 struck Sagaing, Myanmar on 28th march 2025 06:20:54 (UTC) followed by three strong aftershocks. The tremors were felt intensively in India, Bangladesh, Laos, Thailand and China. The earthquake caused complete collapse of the historic Ava bridge and also significant damage to houses and buildings in Mandalay City.
