Earthquake in Myanmar

Earthquake Impact Map of Mandalay City

Observed on 29/03/2025

AOI No.01

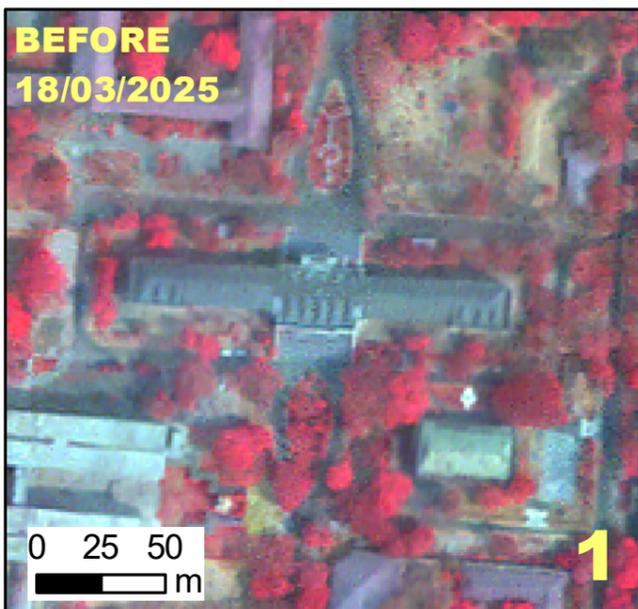
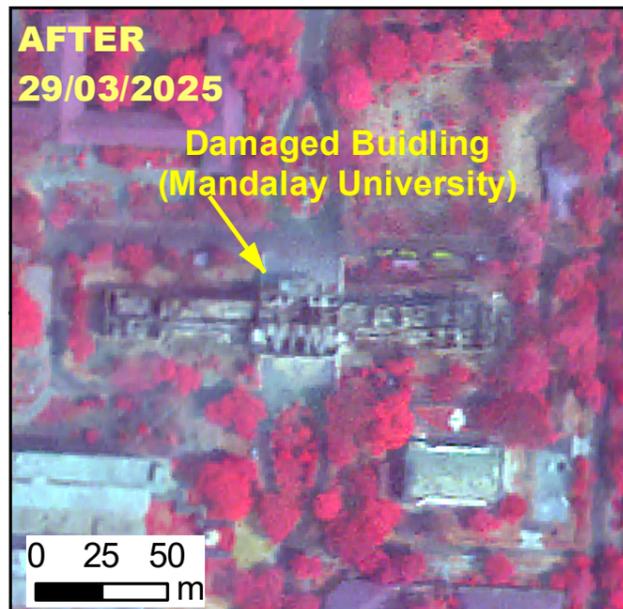
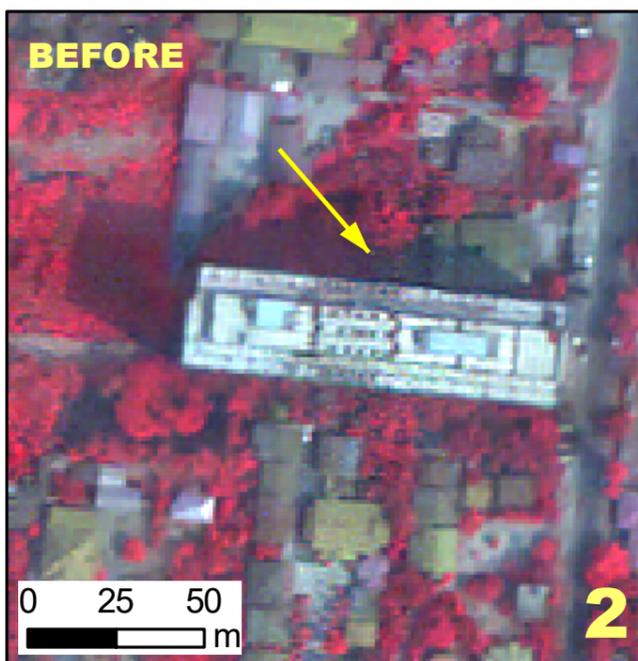
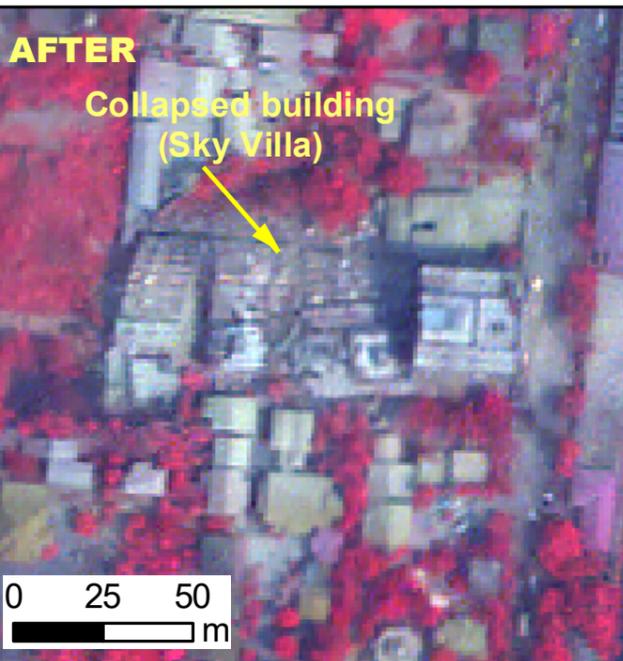
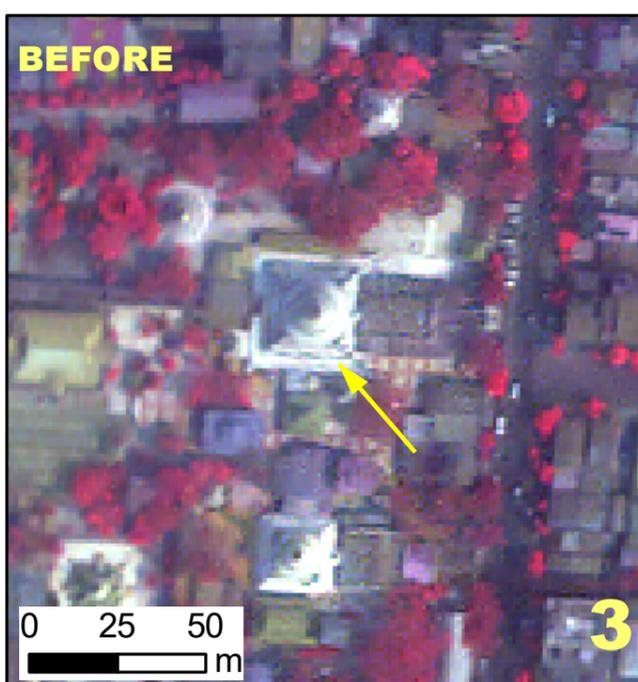
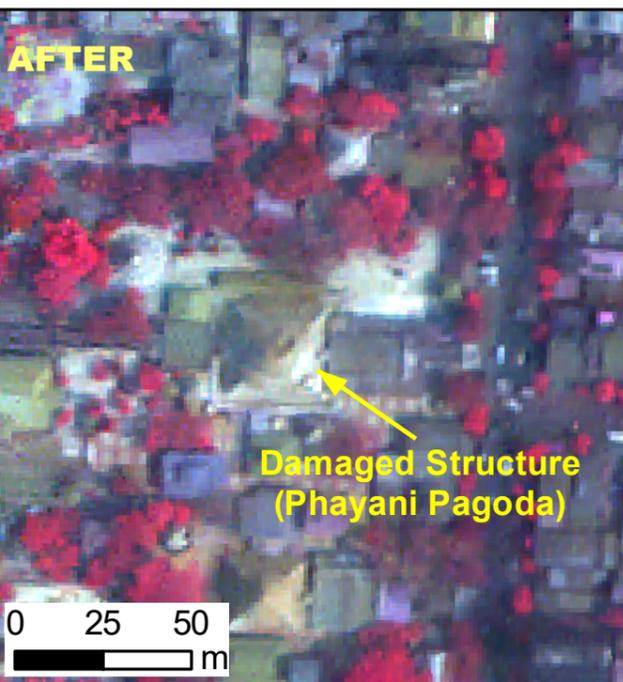
- Fully damage
- Partial damage

Major buildings within the Mandalay City such as Mandalay University, Sky Villa and Phayani Pagoda were significantly damaged.
